City of Wilmington Pedestrian Safety Study

Wilmington Pedestrian Audit

King Street: Front Street to 16th Street

July 14, 2023

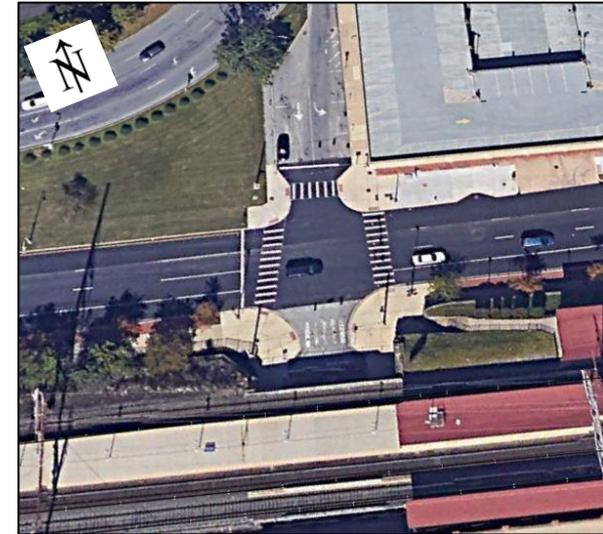
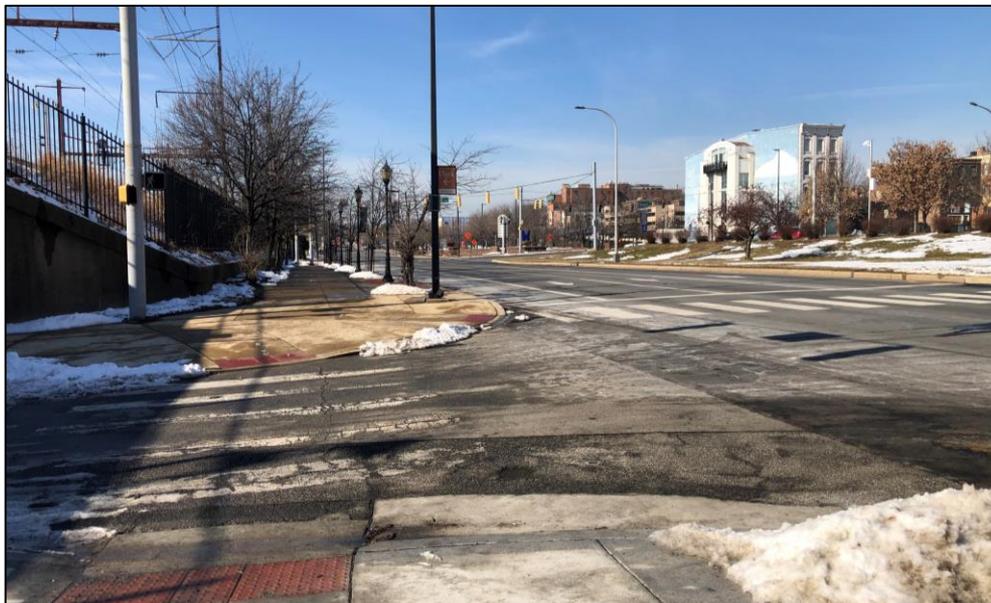
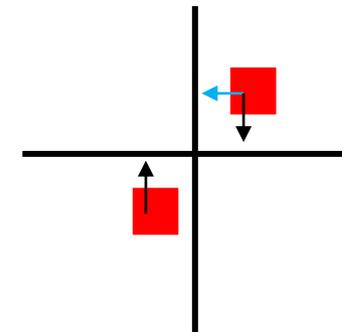
- Zero crashes
- Existing crosswalk on the south leg is faded
- There are two existing ped heads with no countdowns
- There is one existing ped head with a countdown stuck at 20 seconds

*Indicates countdown stuck at 20 seconds

- Refresh faded crosswalks
 - King Street at Front Street south leg
 - King Street at 5th Street north leg
 - King Street at 8th Street north, south, east, and west legs
 - King Street at 9th Street north, south, east, and west legs
 - King Street at 10th Street north and south legs
 - King Street at 12th Street north and south legs
 - King Street at 14th Street north, south, east, and west legs
 - King Street at 15th Street north, south, and west legs
 - King Street at 16th Street north and west legs
- Install missing pedestrian signals
 - King Street at 7th Street – NE and SE corners
 - King Street at 13th Street – NE and SE corners
 - King Street at 14th Street – SE corner

- Upgrade existing pedestrian heads with no countdowns to include countdowns where missing
 - King Street at Front Street (2)
 - King Street at 4th Street (3)
 - King Street at 5th Street (1)
 - King Street at 7th Street (2)
 - King Street at 8th Street (1)
 - King Street at 9th Street (3)
 - King Street at 11th Street (1)
 - King Street at 12th Street (4)
- Upgrade existing pedestrian head to ensure countdown display is not frozen at the King Street and Front Street intersection
- Upgrade existing pedestrian heads to include the walk, countdown, and wait displays at the King Street at 11th Street intersection
- Consider lighting improvements at deficient locations

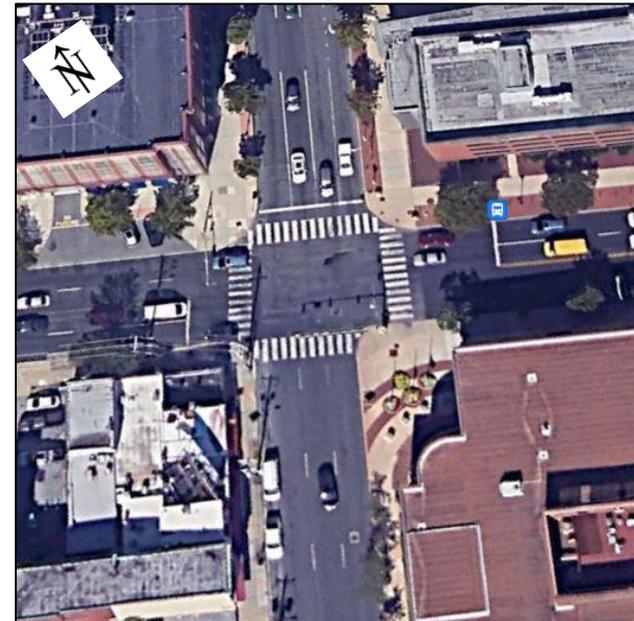
30 crashes

- 16 crashes involving a SBL vehicle striking a pedestrian in the crosswalk (1 crossed against the signal)
- 6 crashes involving a WBL vehicle striking a pedestrian in the crosswalk (1 crossed against the signal, 1 vehicle RLR)
- 2 crashes involving a vehicle reversing and striking a pedestrian
- 1 crash involving a SB vehicle striking a pedestrian crossing against the signal
- 1 crash involving an EB vehicle striking a pedestrian crossing midblock
- 1 crash involving a Dart bus jumping the light and striking a pedestrian in the crosswalk
- 1 crash involving a SB long-boarder crossing against the signal and striking the side of a WB vehicle
- 1 crash involving an unknown vehicle striking a pedestrian in the crosswalk
- 1 crash involving a DUI driver striking a police officer standing next to his patrol vehicle

- Install TURNING VEHICLE YIELD TO PED signs (R10-15) at signalized intersections where RTOR / LTOR is permitted and/or where left turns are permissive
- Consider bumpouts at intersections between 2nd Street and 15th Street where existing parking, a shoulder, and/or travel lanes greater than 12' are present to reduce crosswalk length
- Consider a Leading Pedestrian Interval (LPI) to eliminate the pedestrian / left-turn conflict at the following intersections:
 - King Street at 4th Street
 - King Street at 8th Street

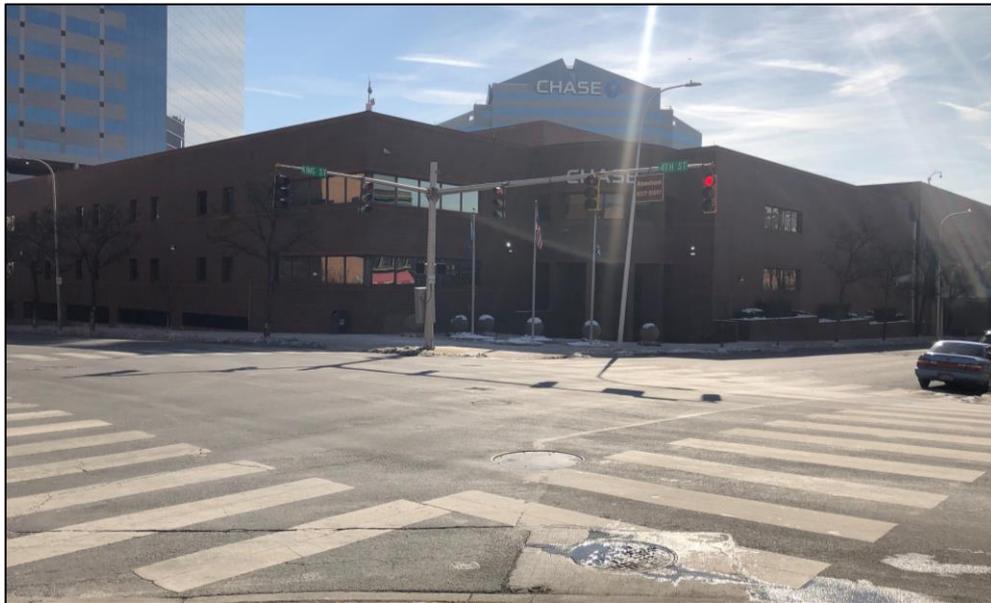
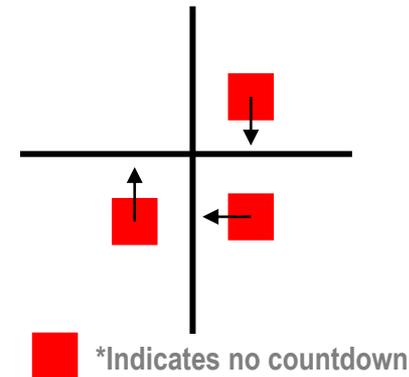
King Street at 4th Street

- There are three existing ped heads with no countdowns
- Midblock pedestrians observed south of the intersection
- 4th Street Road Diet
 - 4 travel lanes will remain in the area of King Street due to traffic volume
 - Improve corridor safety through traffic calming and adding a center left turn lane along 4th Street
 - Provide multi-modal connectivity from west center city neighborhoods to the central business district
 - Integrate bike connectivity via a raised bike lane option
- King Street WB left-turn protected/permissive phasing

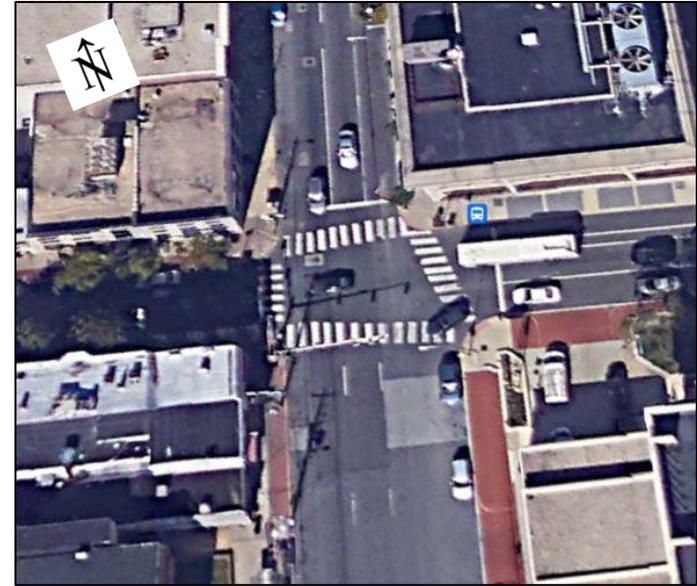
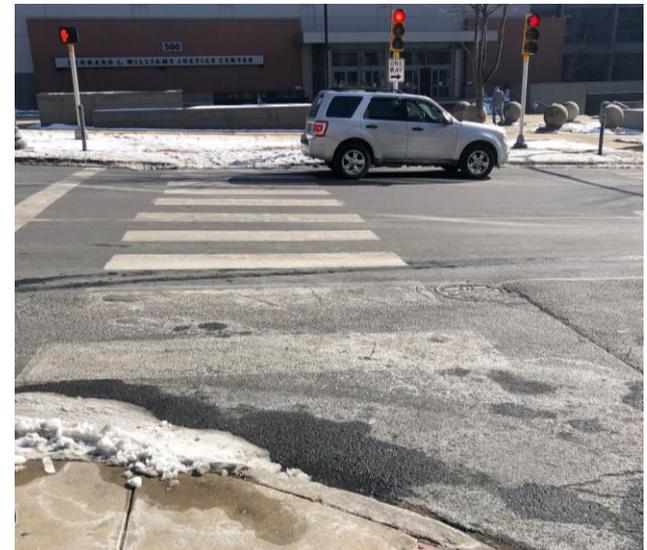
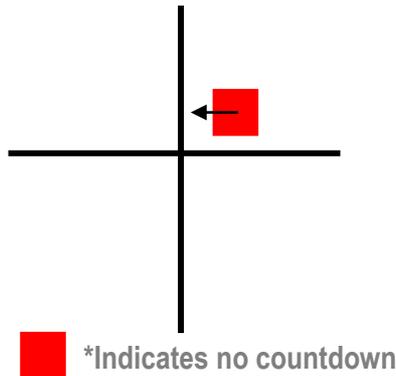
King Street at 5th Street

3 crashes

- 2 crashes involving a SB vehicle striking a pedestrian crossing midblock
- 1 crash involving a pedestrian crossing against the signal and striking the side of a SB vehicle
- Existing crosswalk on the north leg is faded
- There is one existing ped head with no countdown

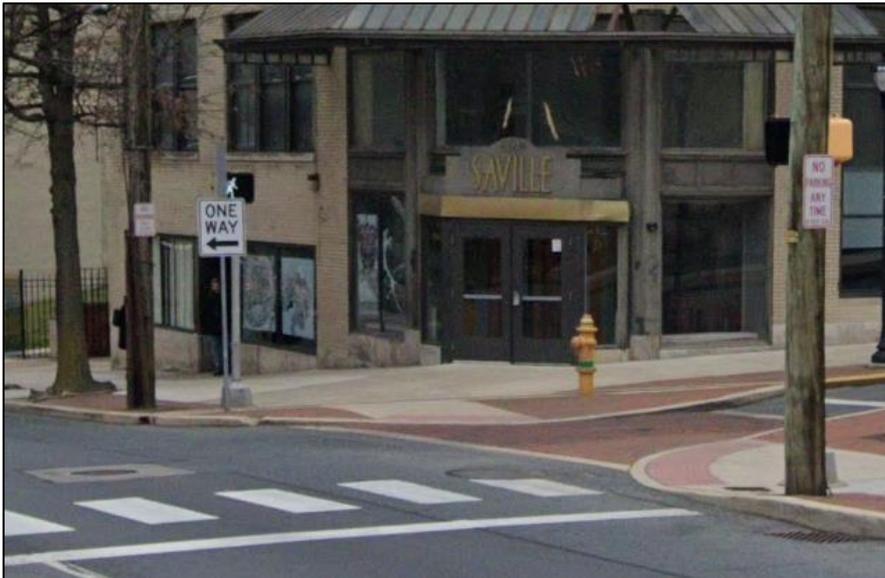
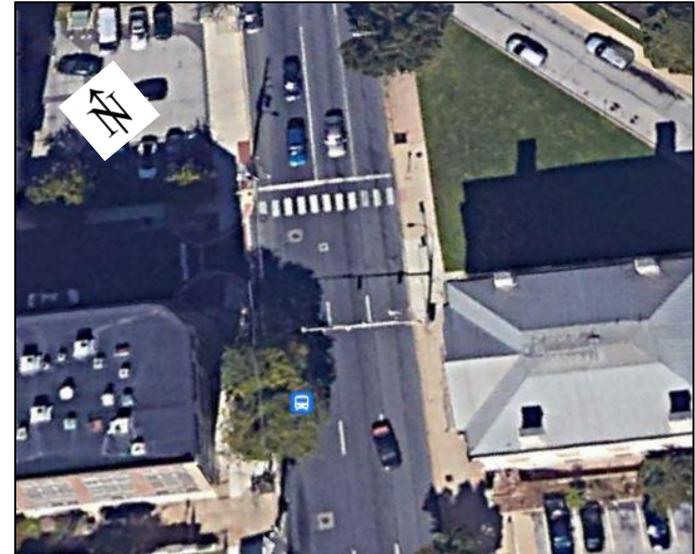
5 crashes

- 3 crashes involving a vehicle exiting/entering a parking lot and striking a pedestrian
- 1 crash involving a bus backing into a parking lot and striking a pedestrian
- 1 crash involving a SB vehicle losing control and striking a pedestrian crossing midblock
- The west crosswalk is brick

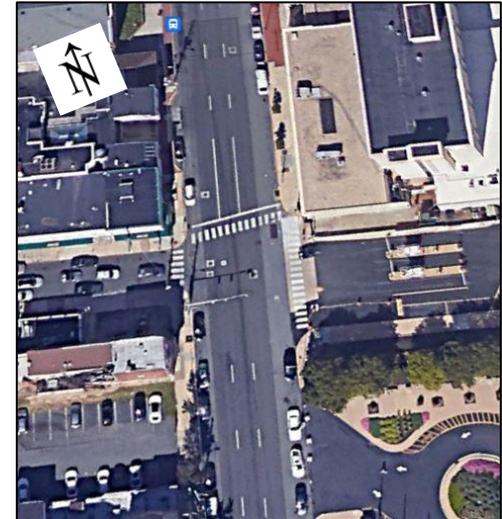
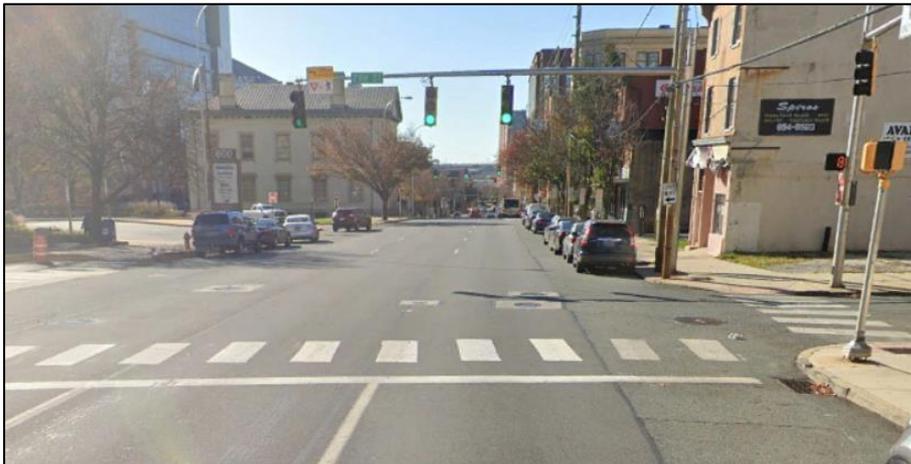
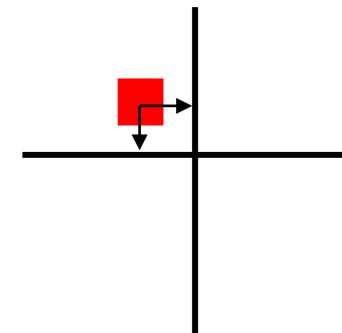
King Street at 7th Street

2 crashes

- 1 crash involving a WBL vehicle exiting the DoubleTree parking lot and striking a pedestrian
- 1 crash involving an EB reversing vehicle striking a pedestrian crossing midblock
- There are two existing ped heads with no countdowns
- There are pedestrian signals missing on the east leg
- Midblock pedestrians observed south of the intersection

*Indicates no countdown

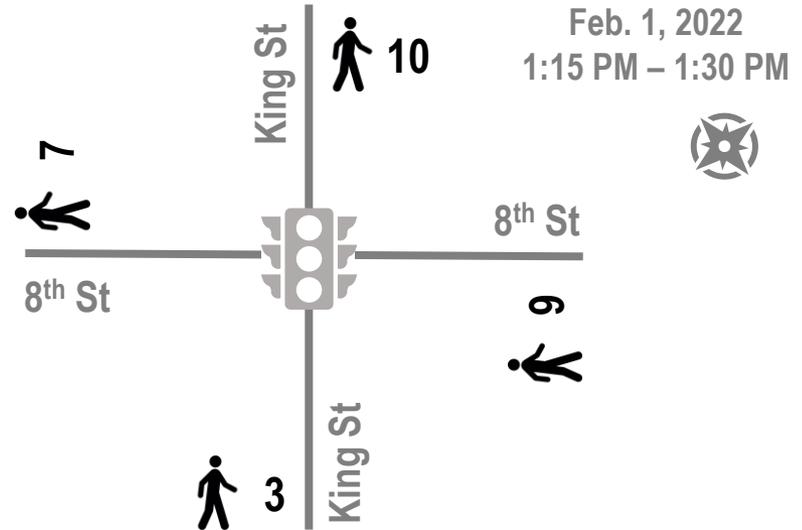
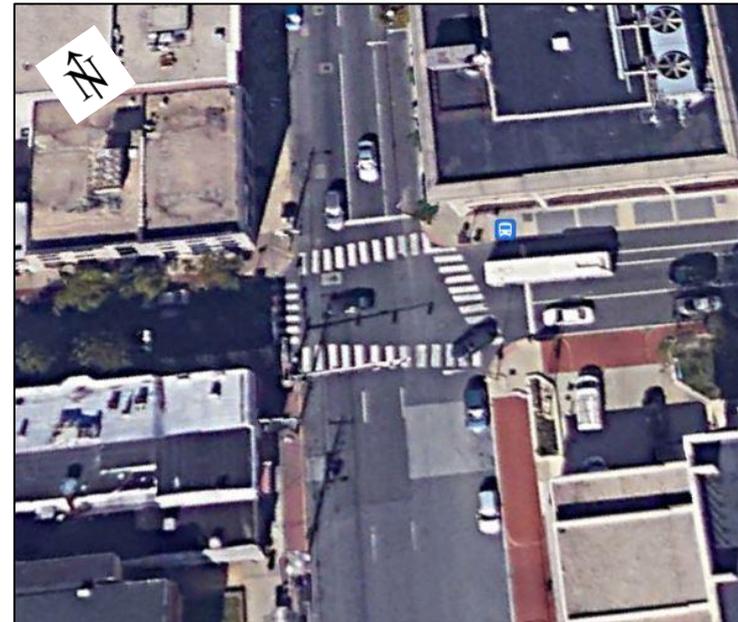
King Street at 8th Street

13 crashes

- 5 crashes involving a WBL vehicle striking a pedestrian
- 3 crashes involving a SB vehicle striking a pedestrian (2 crossed against the signal)
- 2 crashes involving vehicles striking pedestrians crossing midblock
- 2 crashes involving a SBR vehicle striking a pedestrian in the crosswalk (1 crossed against the signal)
- 1 crash involving an unknown vehicle striking a pedestrian in the crosswalk

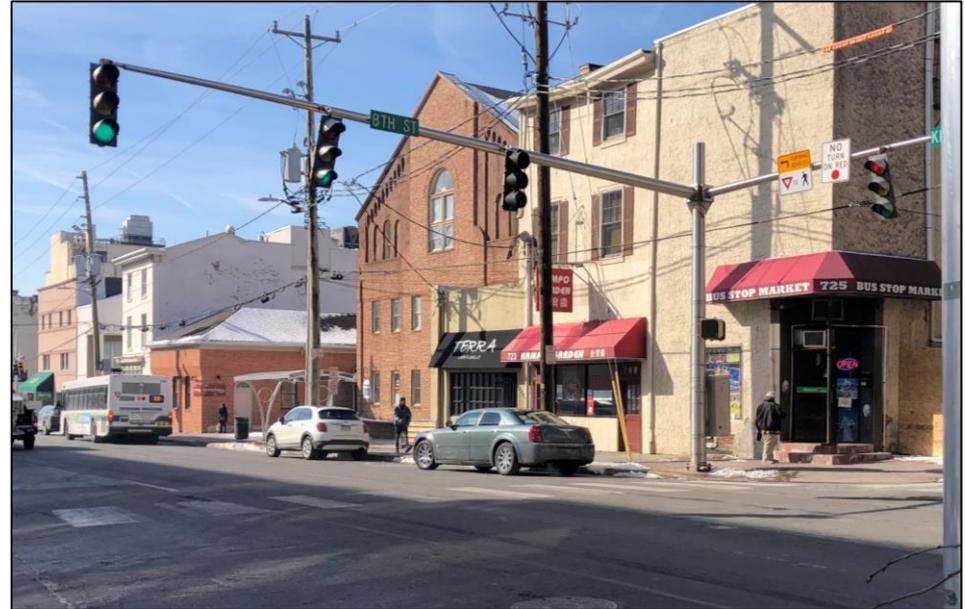
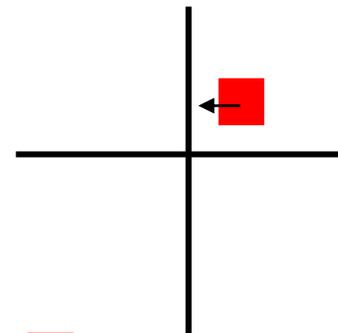
King Street at 8th Street

- All existing crosswalk legs are faded
- There is one existing ped head with no countdown
- Midblock pedestrians observed south of the intersection
 - Wilmington Transit Corridors project includes new bumpout for bus stop at mid-block location south of 8th Street

*Indicates no countdown

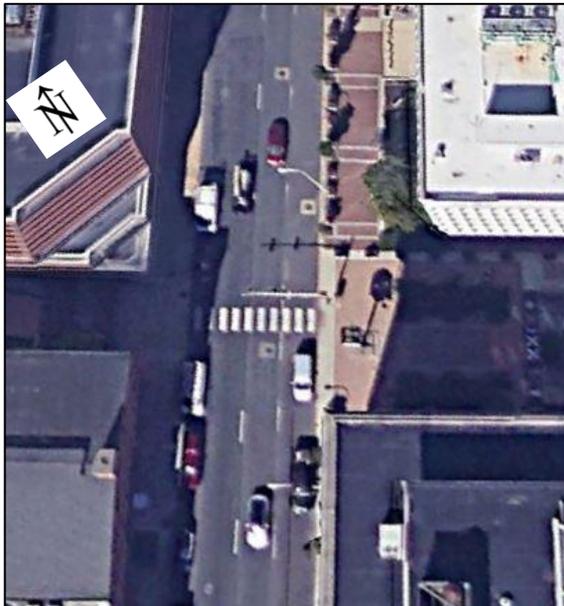
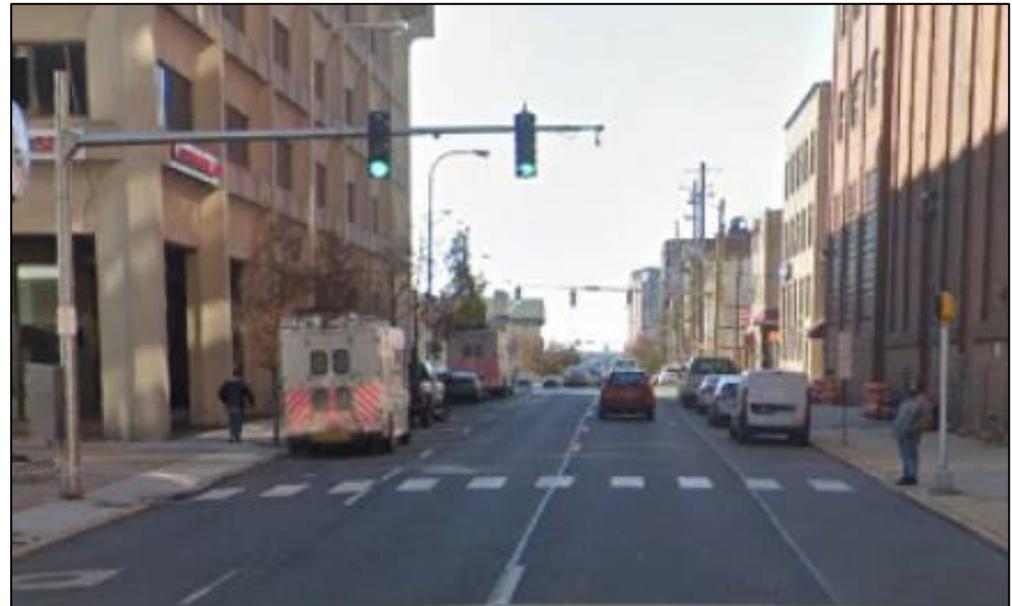
2 crashes

- 1 crash involving an SB vehicle striking a pedestrian crossing midblock
- 1 crash involving a SB vehicle striking a trash collector in the shoulder
- Pedestrian signal is push button activated

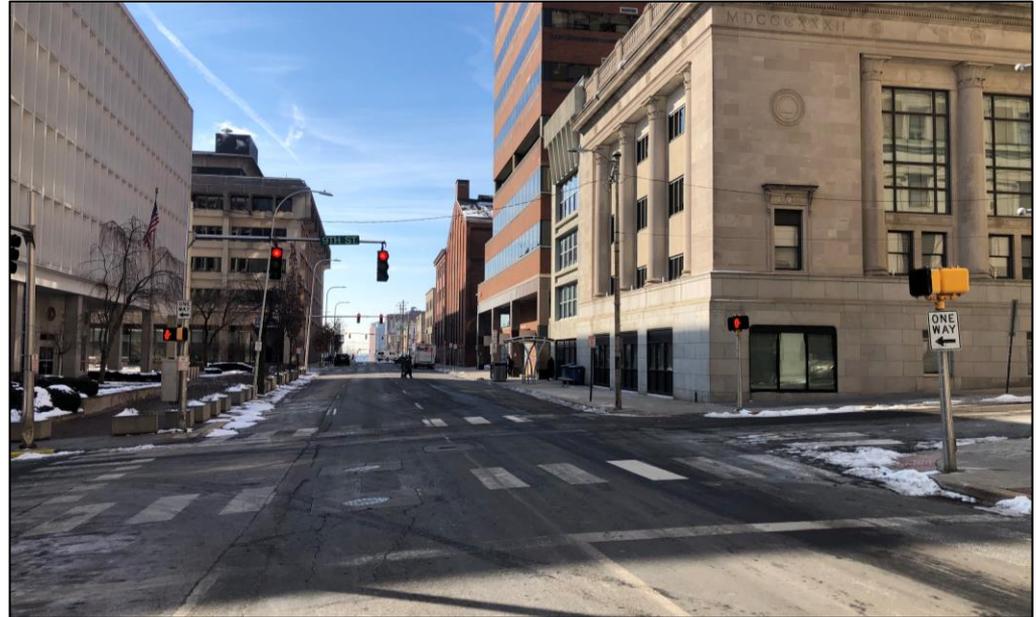
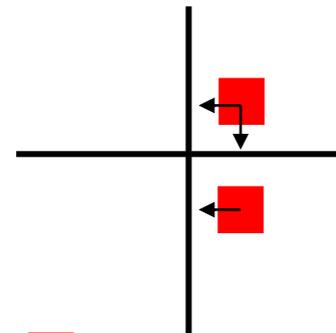
King Street at 9th Street

- All existing crosswalk legs are faded
- There are three existing ped heads with no countdowns
- Midblock pedestrians observed south of the intersection
- Wilmington Transit Corridors project includes new curb ramp and crosswalks at intersection

*Indicates no countdown

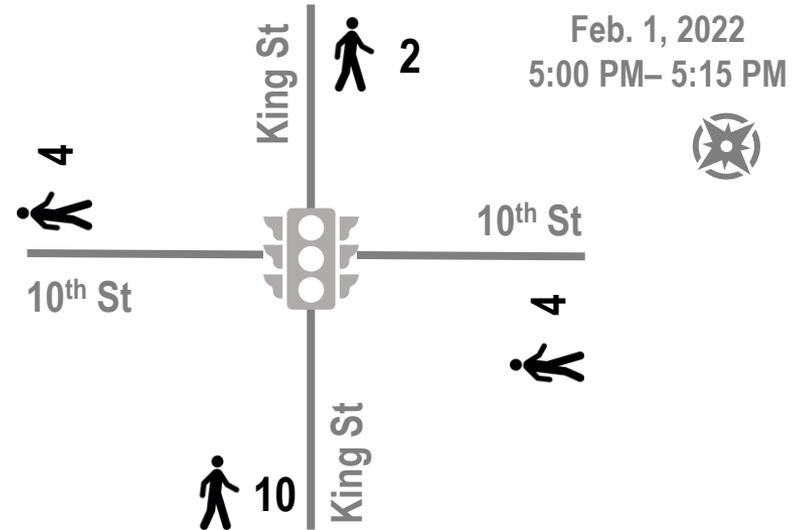
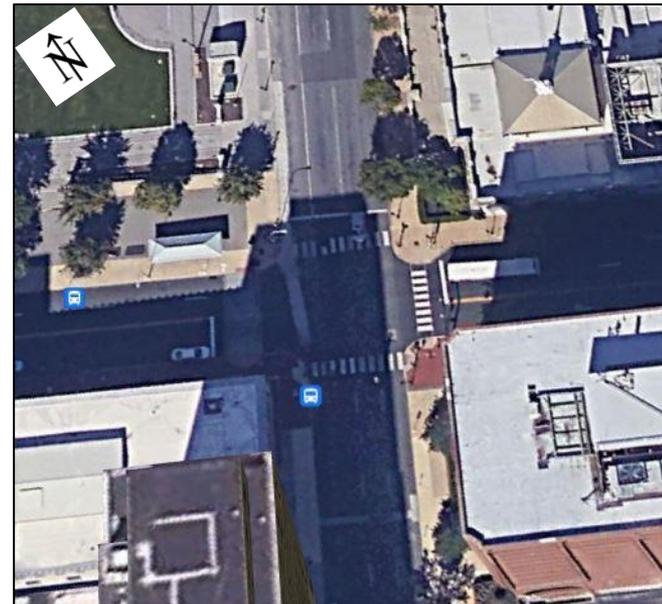
King Street at 10th Street

9 crashes

- 2 crashes involving vehicles striking pedestrians crossing midblock (1 intoxicated pedestrian)
- 2 crashes involving 2 WBL vehicles striking a pedestrian in the crosswalk
- 2 crashes involving pedestrians walking into the side of a WB vehicle
- 2 crashes involving SB vehicles striking pedestrians
- 1 crash involving an EBL vehicle striking a pedestrian in the crosswalk

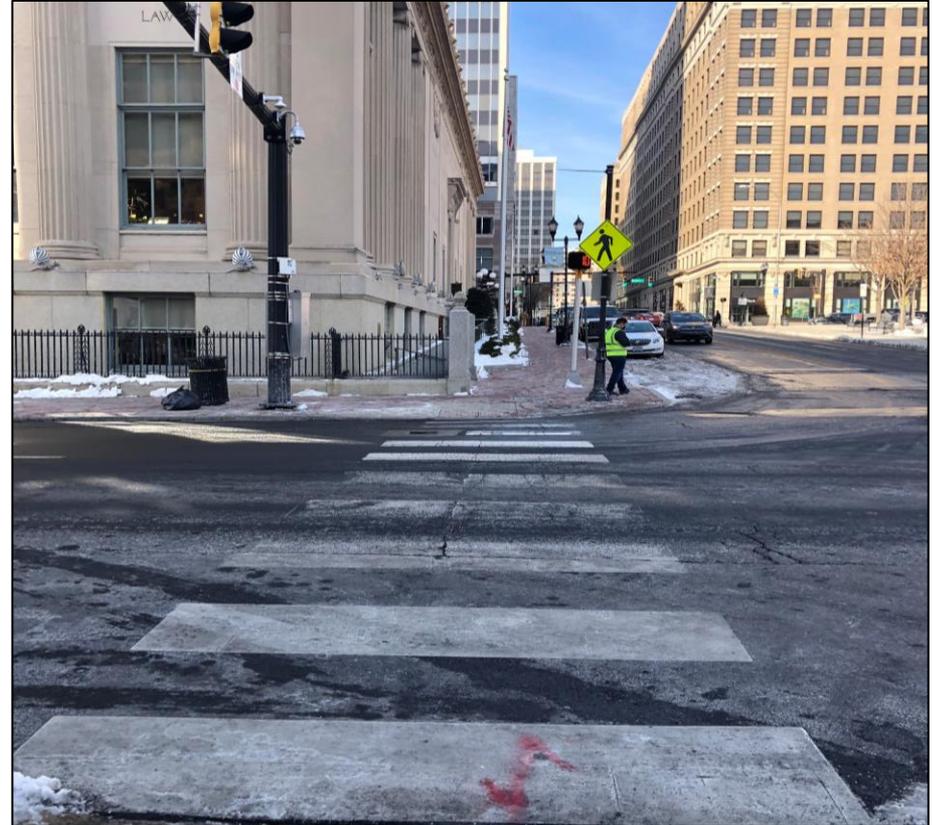
King Street at 10th Street

- Existing crosswalks on the north and south legs are faded
- The west crosswalk is brick
- Midblock pedestrians observed south of the intersection
- SBR and EBR turn on red prohibited
- Wilmington Transit Corridors project includes new pedestrian crossing at intersection

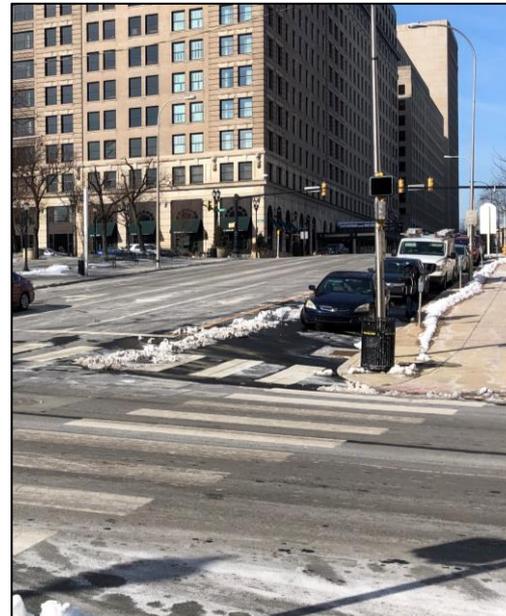
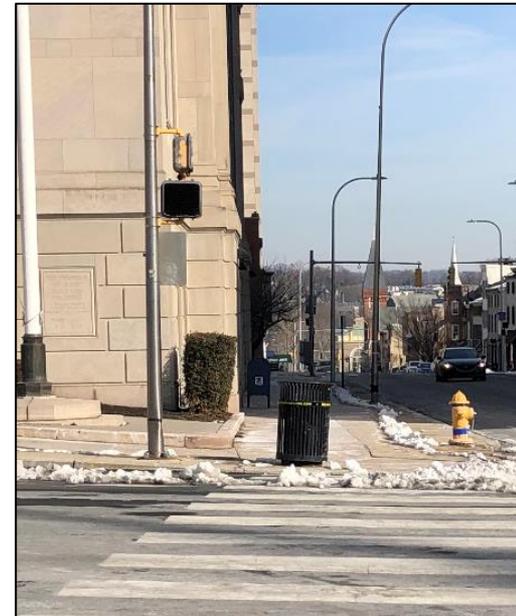
King Street at 12th Street

3 crashes

- 2 crashes involving a WBL vehicle striking a pedestrian in the crosswalk
- 1 crash involving a SB vehicle striking a pedestrian in the crosswalk
- Existing crosswalks on the north and south legs are faded
- There are four existing ped heads with no countdowns
- Midblock pedestrians observed south of the intersection

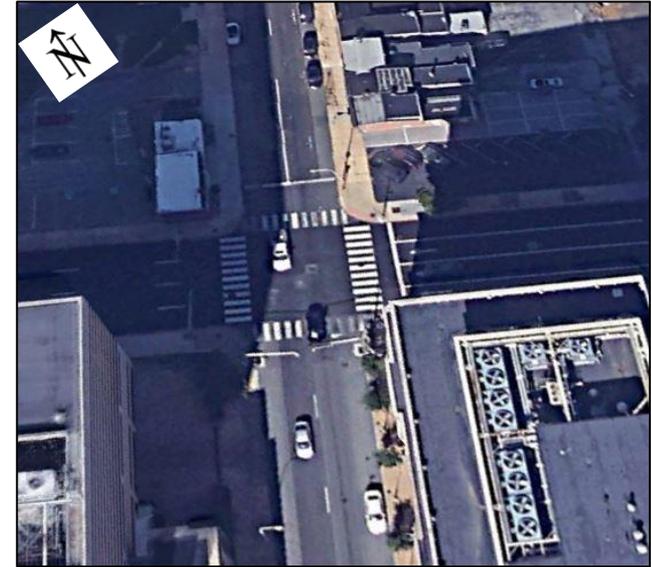
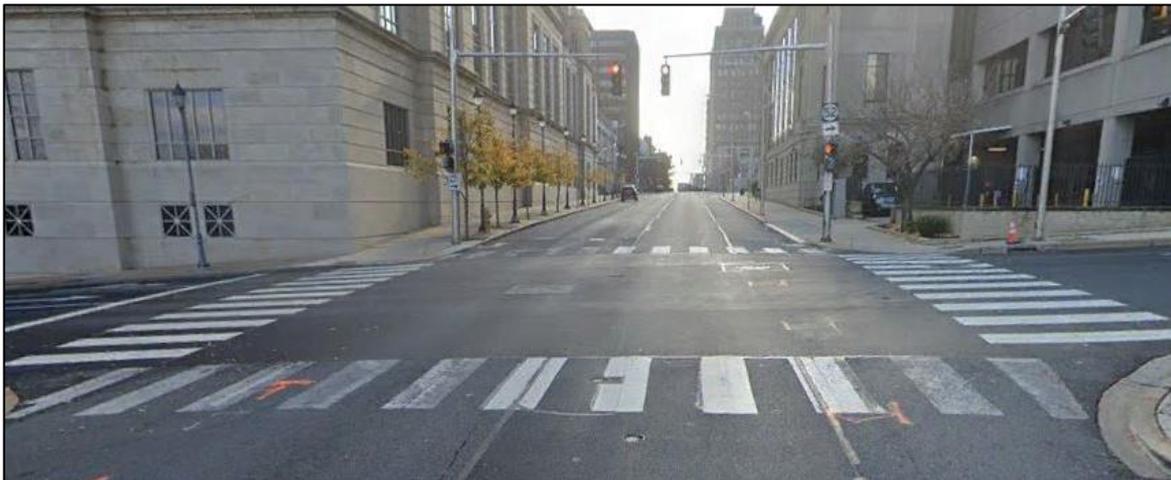
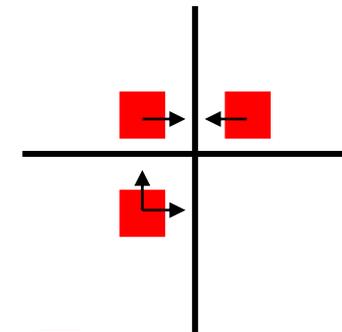
*Indicates no countdown

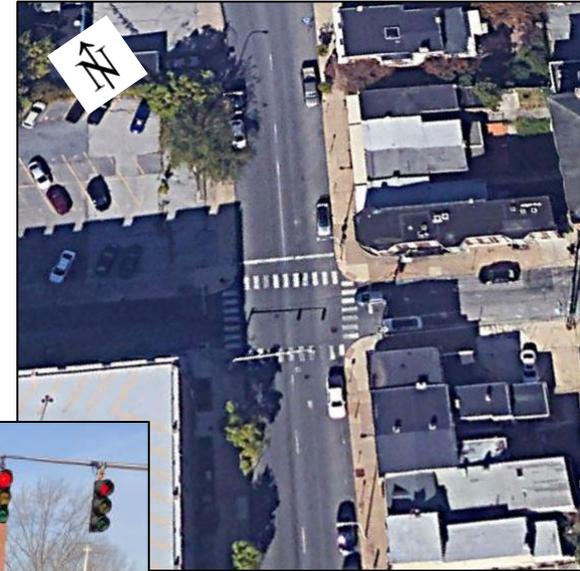
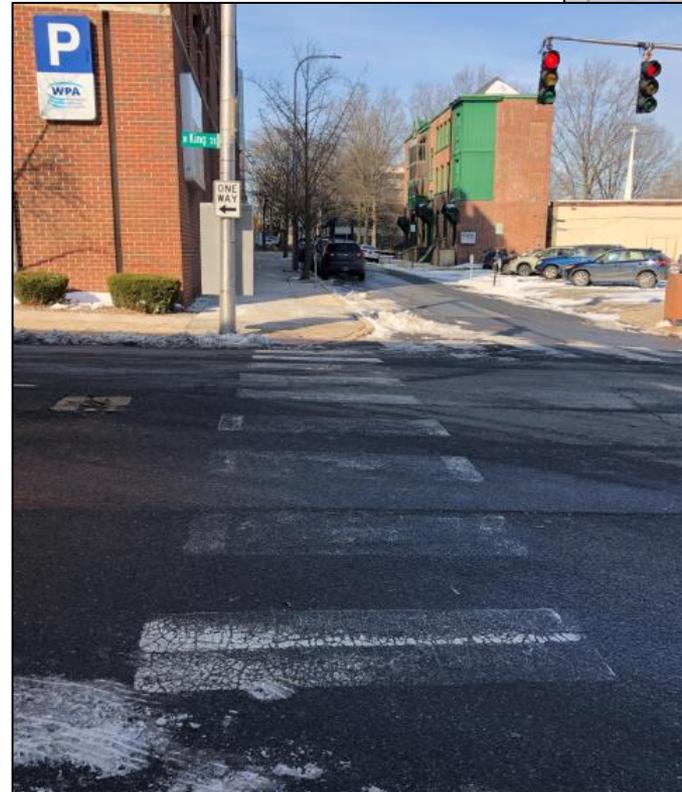
King Street at 14th Street

- Zero crashes
- All existing crosswalks are faded
- On the southeast corner, there are no pedestrian signals
- Midblock pedestrians observed south of the intersection

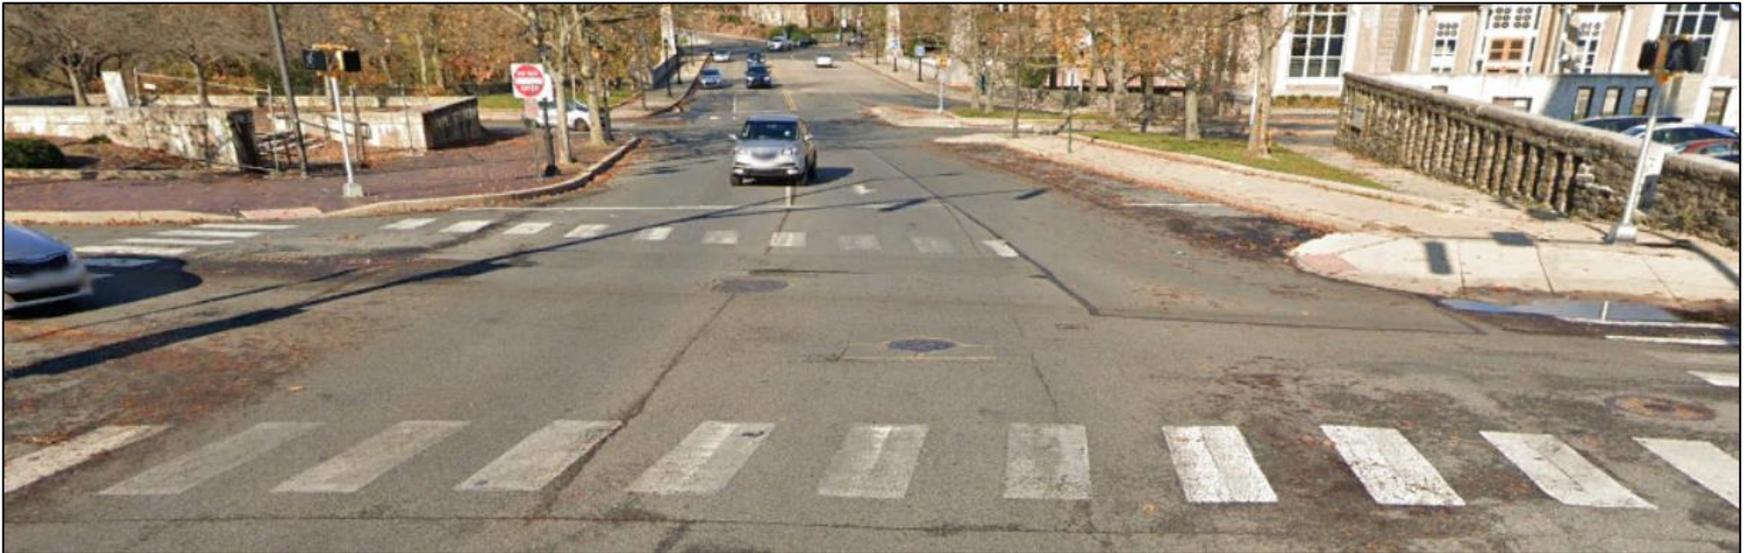
King Street at 15th Street

- **Zero crashes**
- Existing crosswalks on the north, south, and west legs are faded

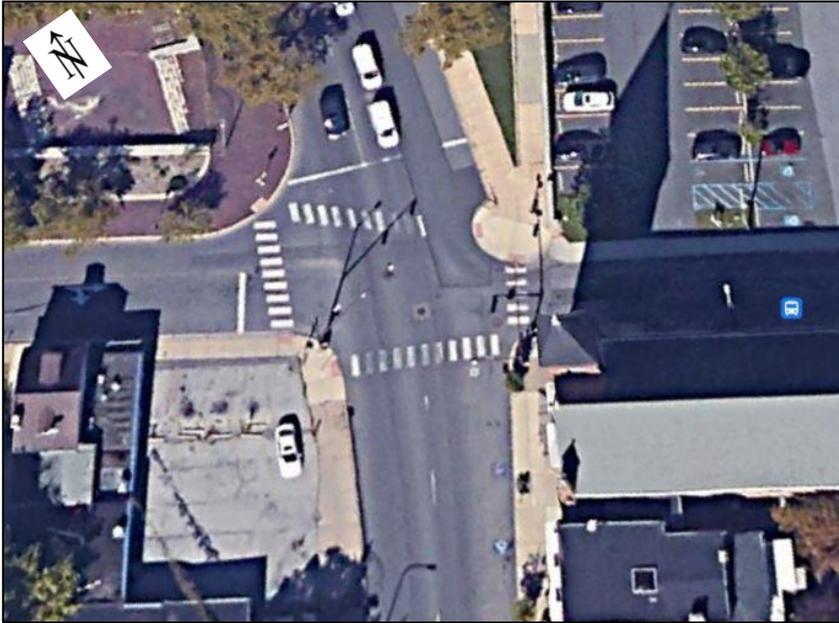
King Street at 15th Street

2 crashes

- 1 crash involving a WBR vehicle running over a pedestrian's foot while waiting at the crosswalk
- 1 crash involving an EBR and striking a pedestrian in the crosswalk
- Existing crosswalks on the north and west legs are faded
- On the south and east legs, there are no pedestrian signals and no marked crosswalks
- Midblock pedestrians observed north of the intersection

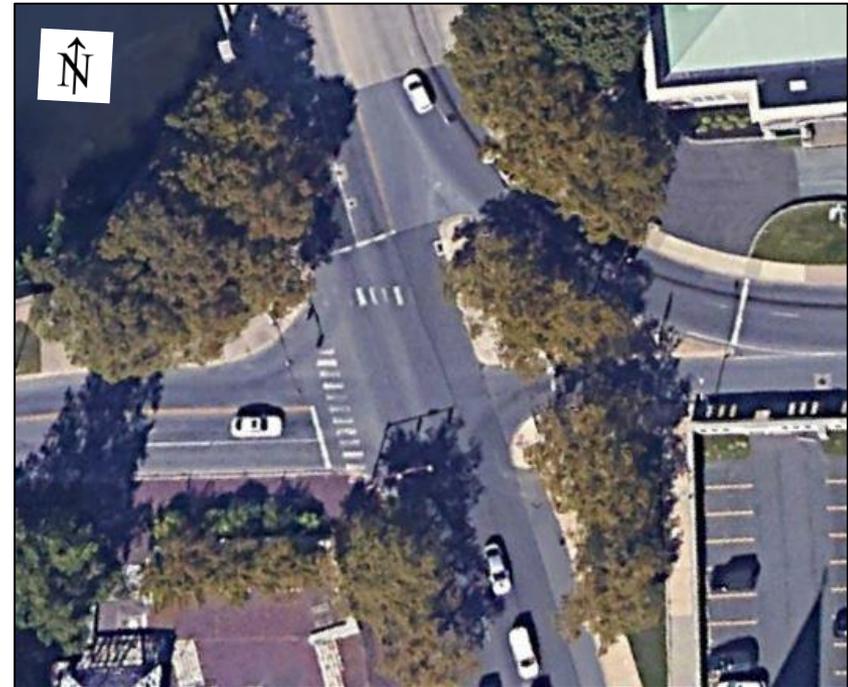
King Street at 16th Street

- 2 crashes involving a pedestrian crossing midblock and being struck by a SB vehicle
- 1 crash involving a WBL vehicle striking two pedestrians in the crosswalk
- 1 crash involving a SB vehicle striking a stationary pedestrian while performing work duties
- The west crosswalk is brick
- Midblock pedestrians observed south of the intersection
- Wilmington Transit Corridors project is adding a bump out at this bus stop
